Final report RL 2012:21e

**Serious incident on 16 of January 2010 to
aircraft EP-IBB at Stockholm/Arlanda
Airport, Stockholm county, Sweden**

Ref.no. L-02/10

2012-12-28

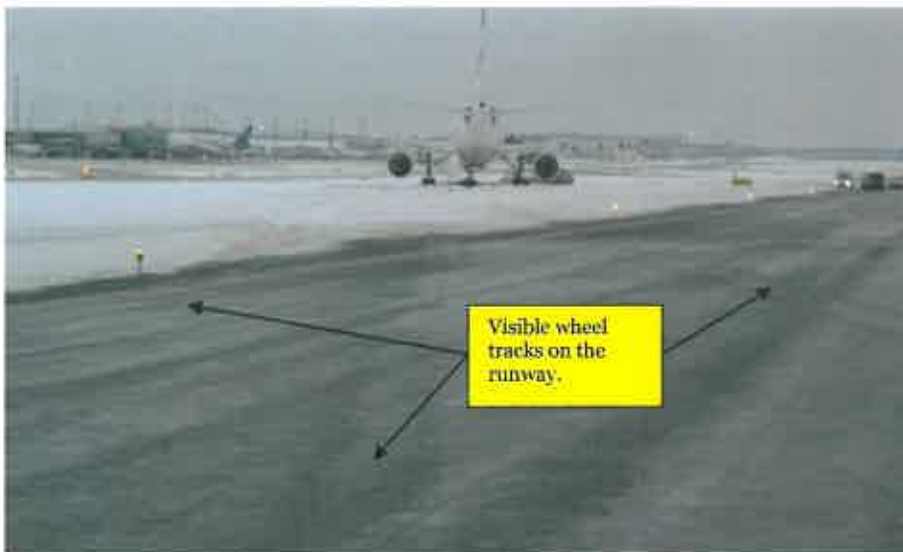
Both SHK and the airport staff have photographed the runway and the aircraft after the incident, see figs. 35b and 50. Judging by the images, the runway seems to have been covered with a grey contamination, in contrast to the appearance of the runway in the video recordings. Tracks from the aircraft’s wheels are clearly seen in the contamination on the runway and in the snow outside of the runway. The landing gear is fitted with wheels mounted in pairs with a common axle and the main landing gear each has two pairs of wheels mounted in tandem. Double wheel tracks from main landing gear and nose landing gear can be seen on the runway surface in the images.

Fig. 35b. Tracks on the contaminated runway surface. Photo: Swedavia.

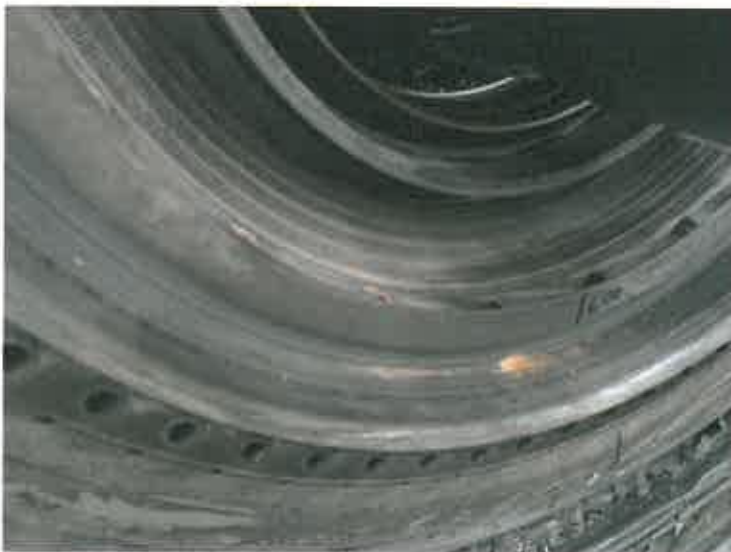
Sealing surfaces for the diffuser's forward seal (Diffuser Front Seal) were intact and had normal wear. Sealing surfaces in the form of the stationary honeycomb for the diffuser's aft seal (Diffuser Aft Air Seal) were torn away. The bolts which hold together the forward and aft seals against the diffuser were overstressed and sheared off. The edge of the seal normally lies parallel with the engine's longitudinal axis, but in this case it was angled outwards at 45°. Extensive impact damage was ascertained on the parts of the module that were directed towards the HPT disc stage one.

Fig. 37. Stationary seal, forward and aft (honeycomb completely torn away). Photo: SHK.

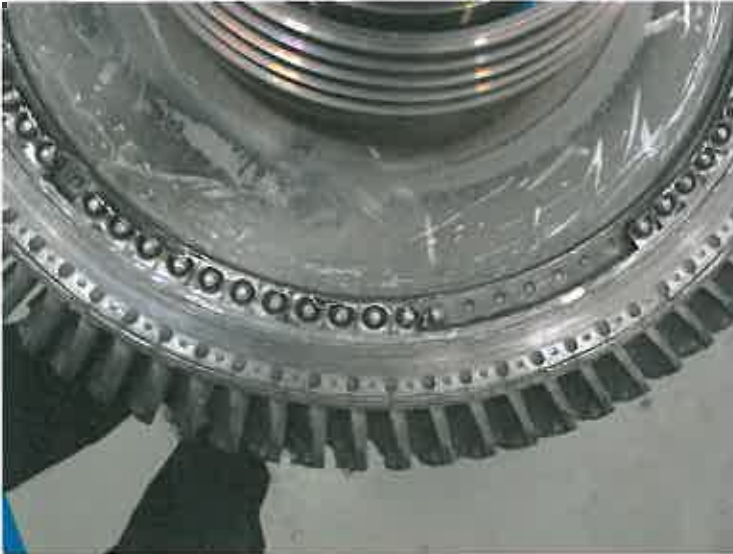
All blades were damaged through mechanical impact. The tops of the blades were entirely or partly torn away.

Fig. 38. HPT disc and turbine stage one with Diffuser Front Seal.
Photo: SHK.

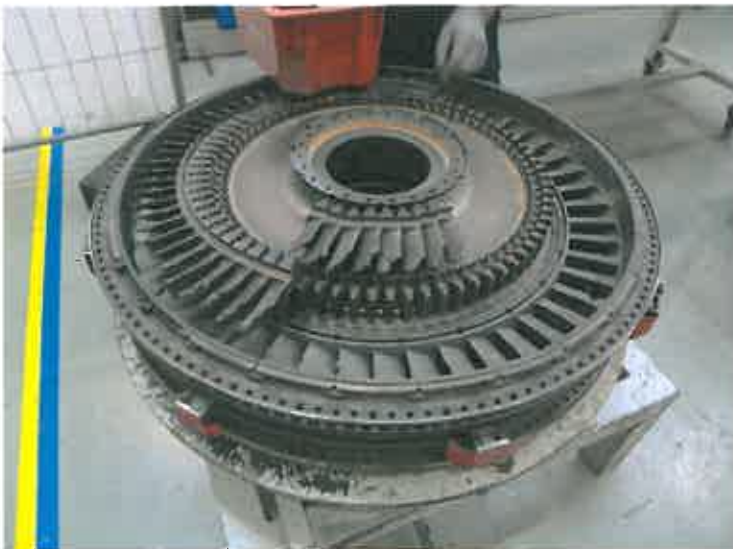
Seven of the eighty bolts which axially secures the stage 1 HPT Blade retainer to the stage 1 disk, also known as the 1st stage HPT blade retainer "Hook Bolts", were found broken just under their windage cups. Six of these seven bolts were adjacent to each other. One broken bolt was located 12 bolt holes beyond the others.

Fig. 39. HPT stage two. Photo: SHK.

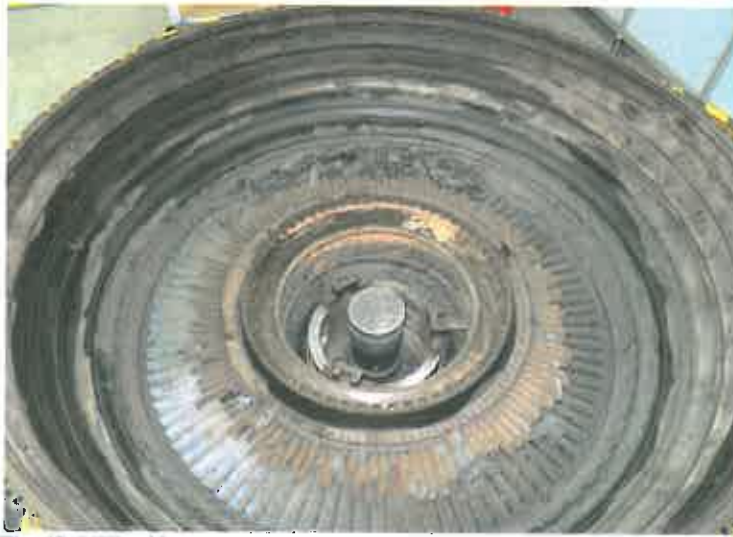
Throughout all five stages of the low pressure turbine, impact damage to both the low pressure turbine blades and guide vanes were observed. The amount of damage decreased further back in the low pressure turbine module. The low pressure turbine case was examined and found to have penetrations measuring around five by five millimeters. It has not been possible to conclude if debris passed through the holes. The LPT case was also observed with a number of case deformations in the radial direction.

Fig. 40. LPT guide vanes and turbine blades stage two. Photo: SHK.

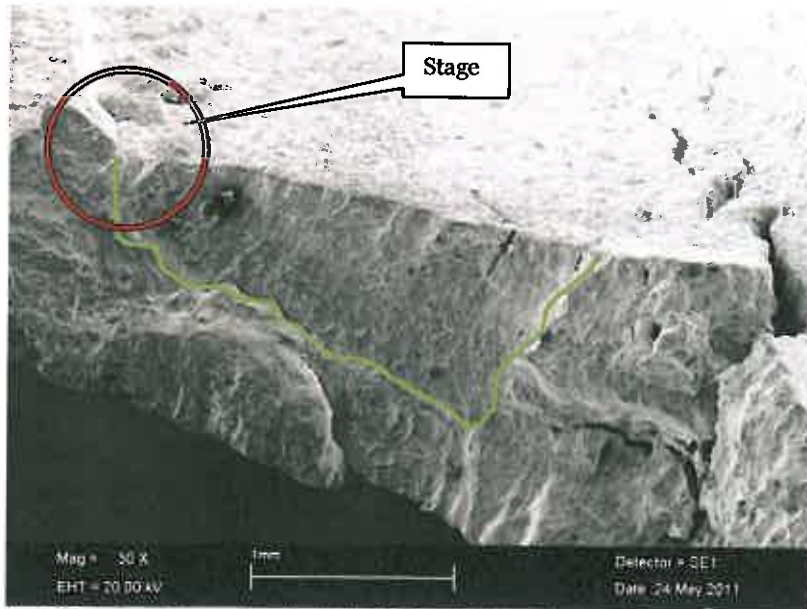
The overall assessment of the investigation results suggests that the fatigue had started in the repaired seam at the diffuser aft air seal teeth. All documented cases of CF6-80C2 diffuser aft air seal failures have been seals that had been previously repaired.

Fig. 45. Section of the knife edge in the diffuser aft air seal – one of four edges. Fatigue zone with crack initiation. Photo: VAC.

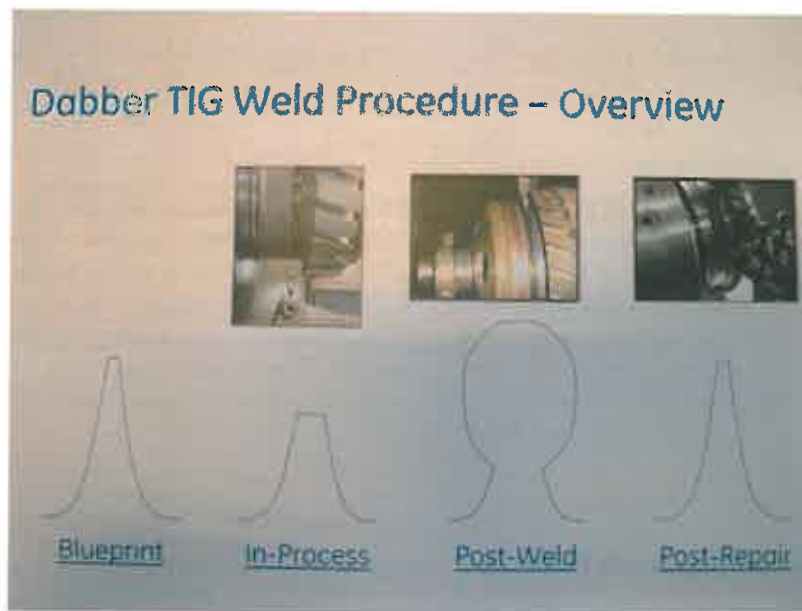
The seal material is Inconel 718. During a repair, the seal edges are dabber-welded in an age-hardened state (aged). The risk for crack formation is thereby greater in weld and heat-affected zones. For newly manufactured engine parts using TIG Weld operations, however, Inconel 718 is always welded in a solution-heated state. The material is then more ductile and has lower hardness.

Fig. 48. Repair with the GE method “Dabber⁵⁵ TIG Weld ”.

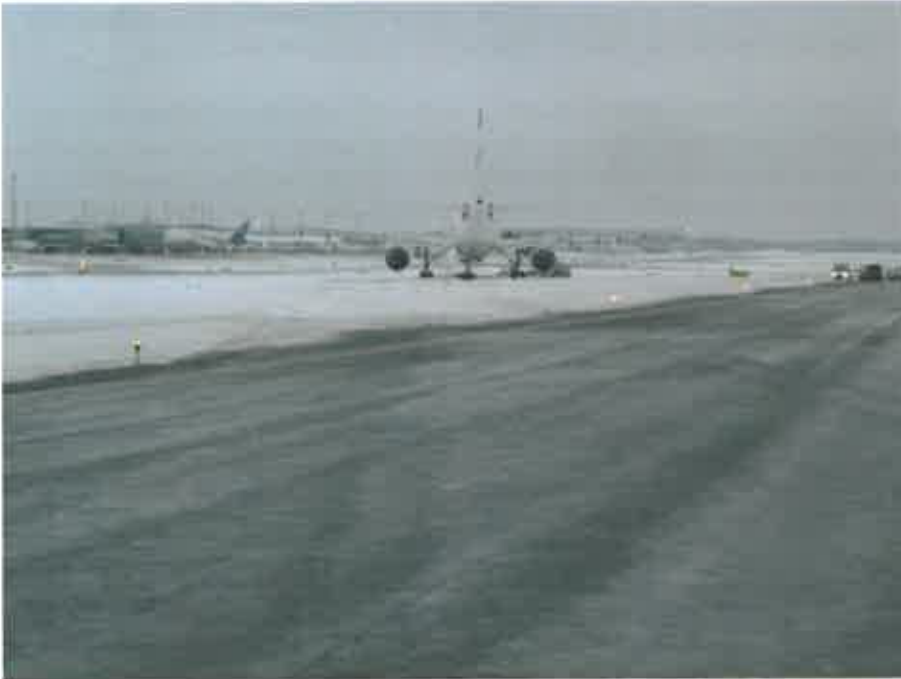
The contaminated surface must be concluded to have affected the friction negatively, however not to the extent of causing aquaplaning since the aircraft speed was too low for that.

Fig. 50. (See also fig. 35b). Tracks on the contaminated runway surface. Photo: Swedavia.

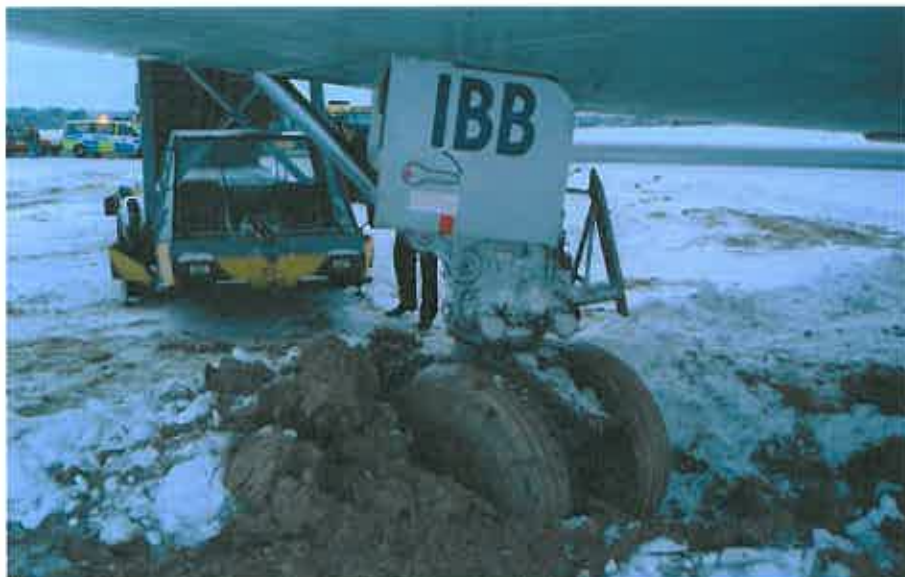
steering wheel (tiller) in the cockpit. These facts are supported by the fact that the aircraft – after having stopped – was found with the nose wheel at an angle fully to the right.

Fig. 51. The nose wheel angled to the right. Photo: Swedavia.

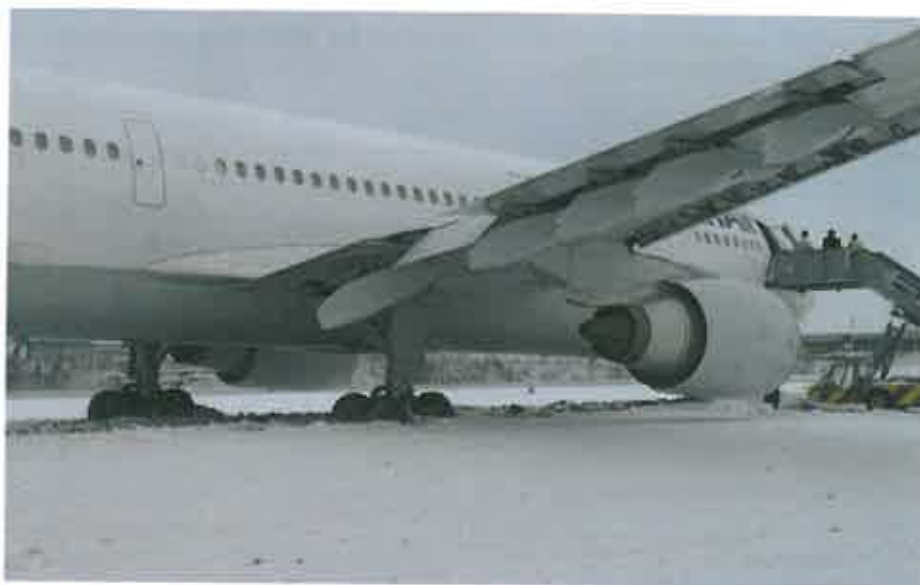
During the final stage of the aircraft’s path, the nose wheel buried itself approximately half a metre into the ground, partly due to the nose wheel being maximally angled to the right. The steering wheel for the nose wheel steering is not intended for use during the take-off sequence as steering via the rudder pedals is considered to be sufficient. However, when an aircraft is about to run off the runway, it is fully understandable that all means are used by the pilots in attempt to prevent an accident.

Fig. 52. The aircraft after evacuation. Photo: SHK.

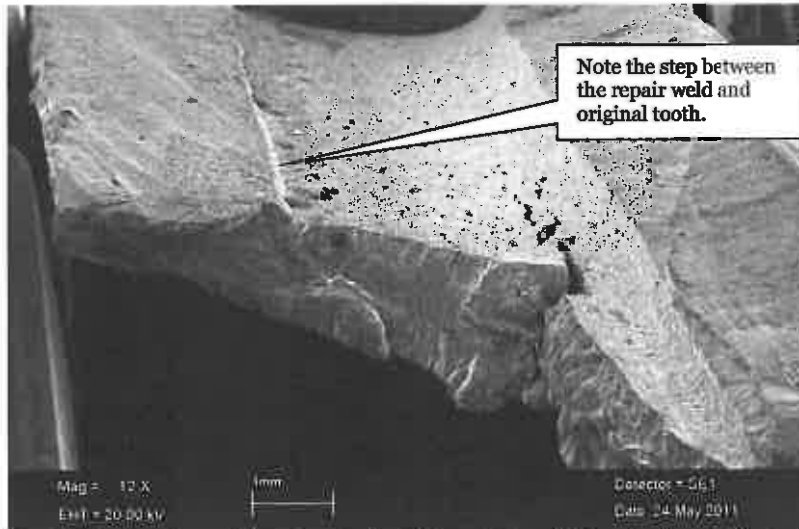
Fig. 58. Section of one of the edges in the diffuser air seal. See also fig. 45. Photo: VAC.

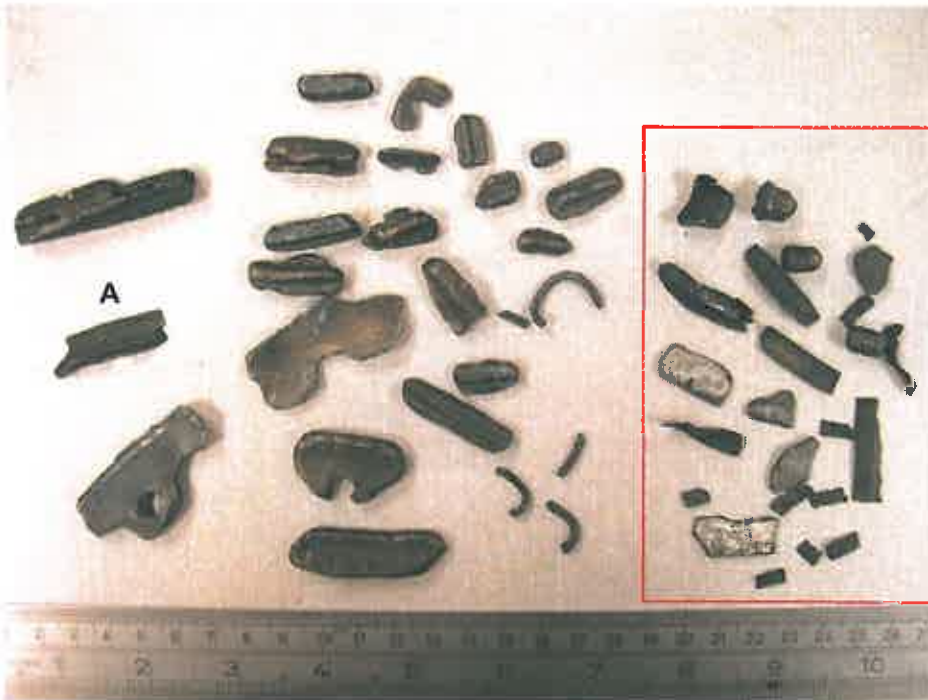
Photo No 1. Content of the plastic bag. The pieces within the red marking are not believed to be from the Diffuser Aft Seal based upon visual appearance and geometry. The piece marked "A" is from the aft tooth of the seal.

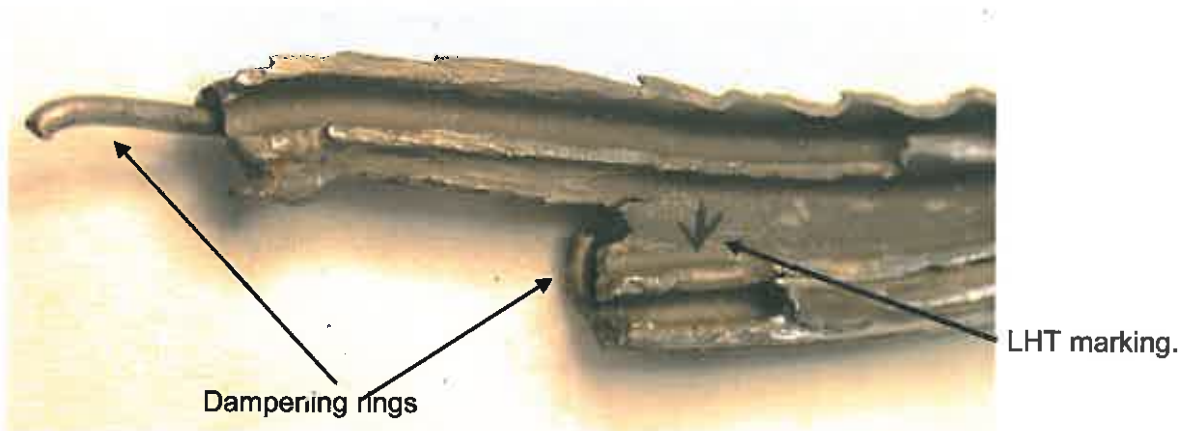
Photo No 6. Both dampering rings were in place at the failure.

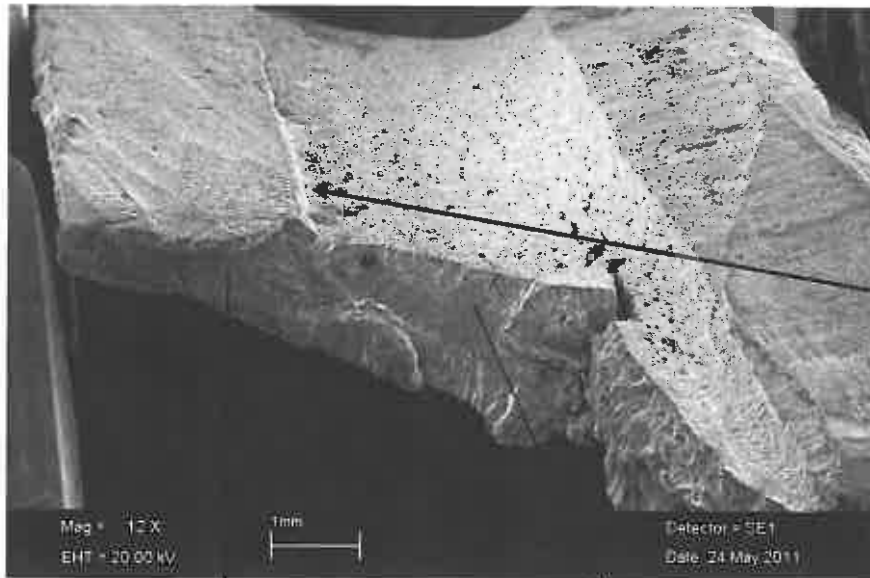
Note the step between the repair weld and original tooth.

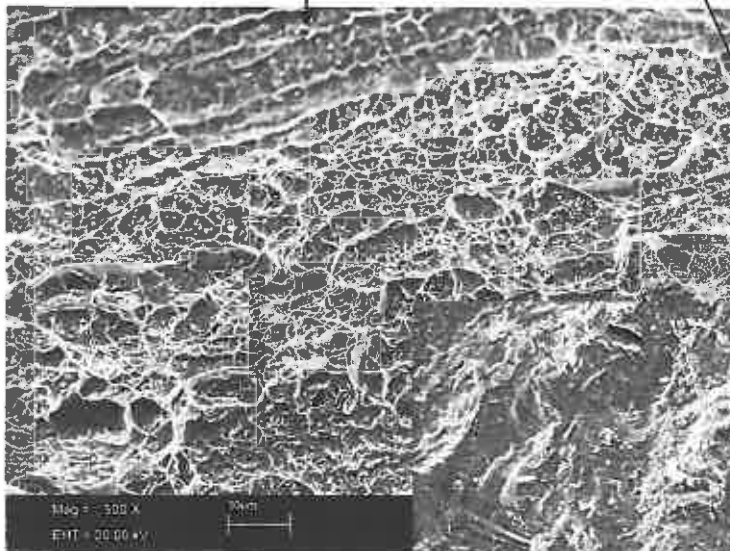
Photo No 10. Tensile overload (weld) structure.

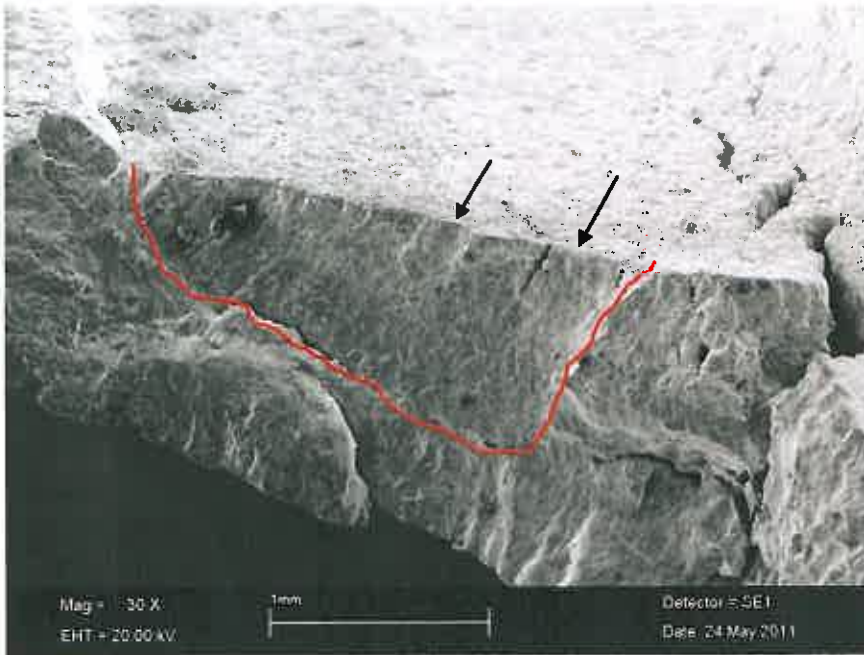
Photo No 12. Fatigue surface outlined with red. Arrows show two crack initiation points.

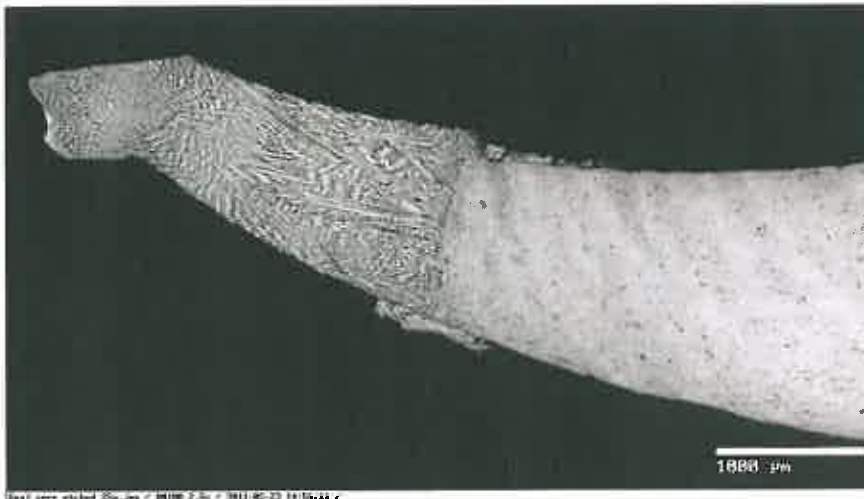
Photo No 13. Cross section, in etched condition, shows the seal tooth with the dabber weld repair.

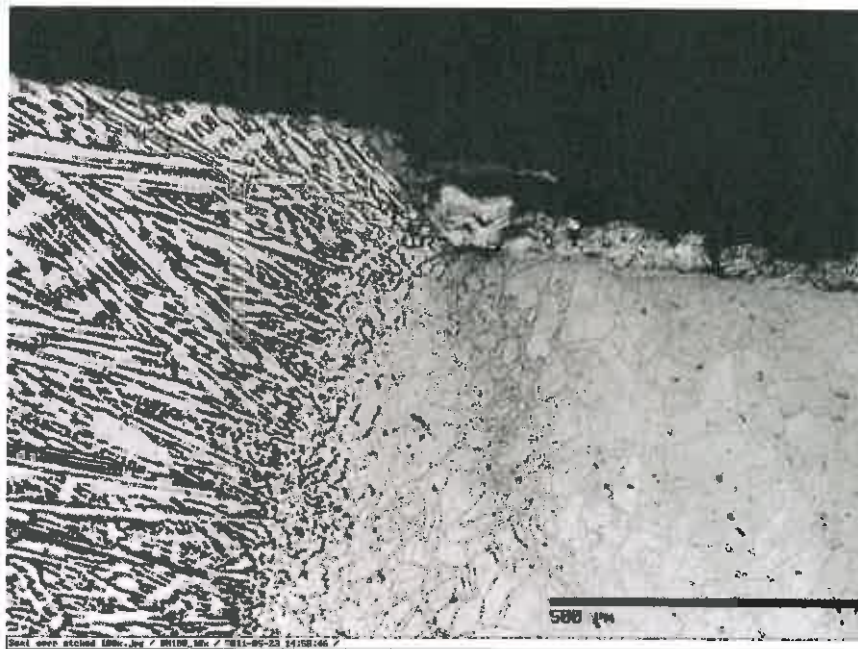
Photo No 15. Higher magnification of the area in the red rectangle in previous figure shows the machining step between the original seal and the repair weld.

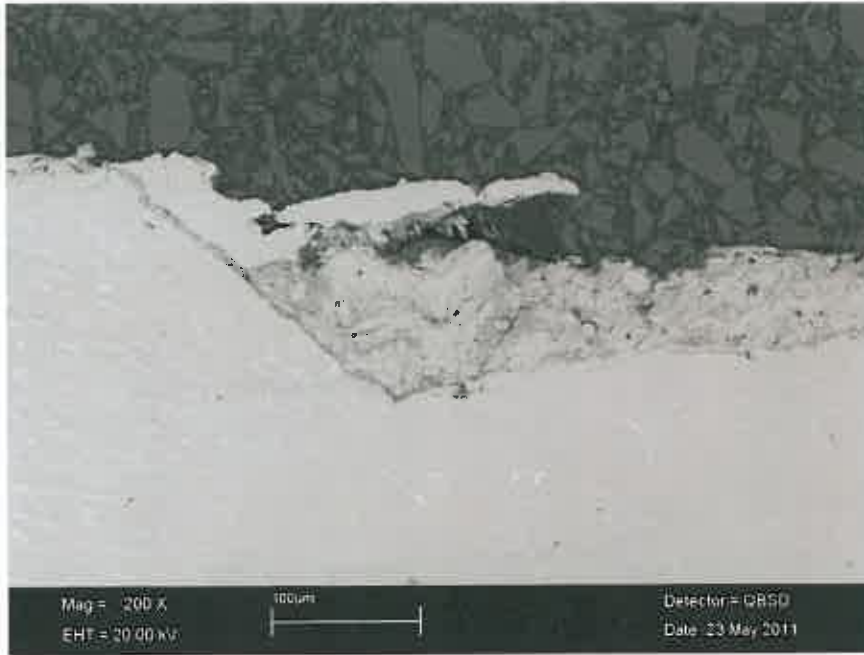
Photo No 16. SEM-photo in 200X shows that the bottom of the machining step between the original seal and the repair weld is considered to be a sharp corner.

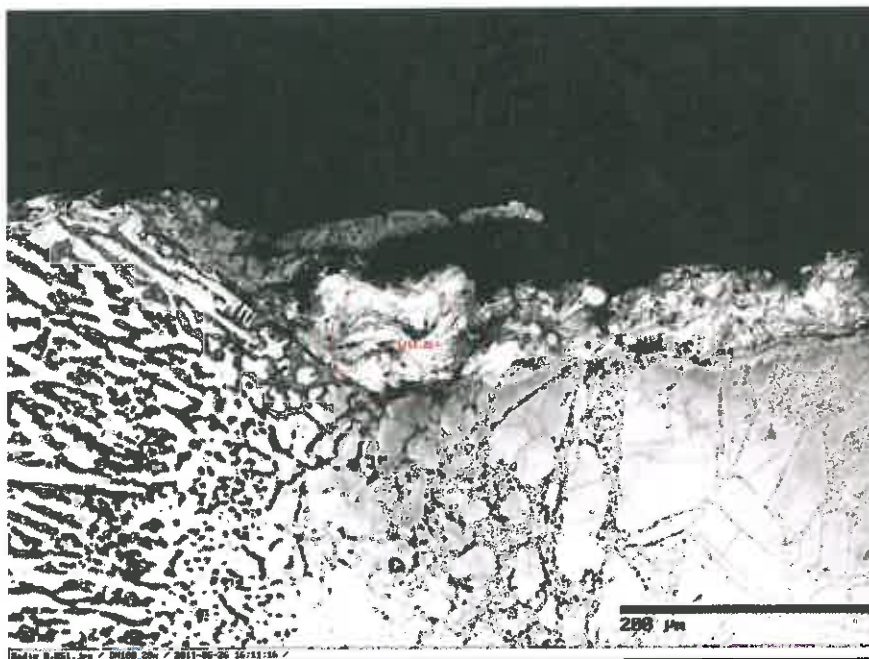
Photo No 17. The radius of the machining step is measured to be 0.05mm.

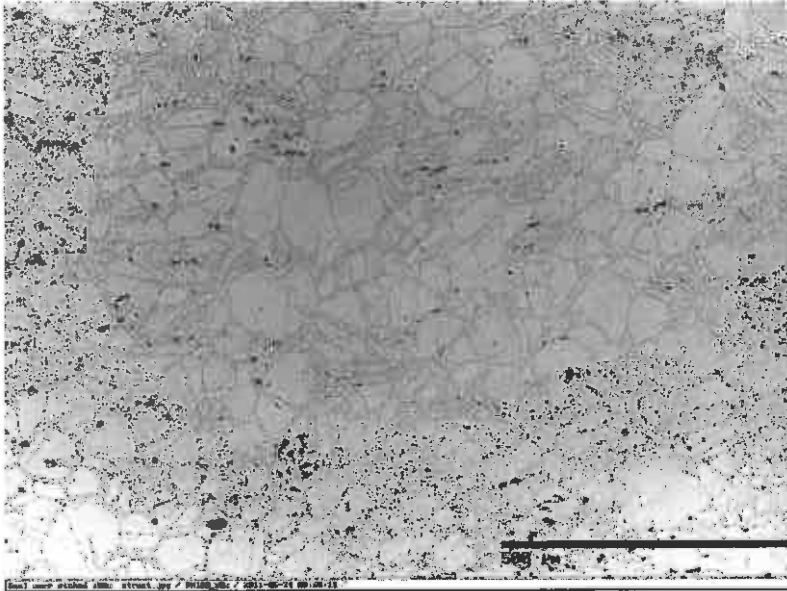
Photo No 19. Microstructure of the seal tooth, about 3 mm from the weld interface.
